# Manhole Inspection Summary

Manhole # S21C1\_005MH

Insp Date: **5/21/08 10:31 AM**

**Location** Address: **2508 paca st**

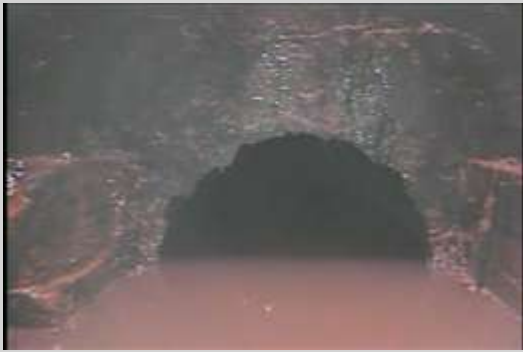
6 O'Clock Inflow

24 in. Circular Gravity Sewer

Pipe In @ 6 O'Clock

Pipe Height: **24** (in.) Rod and Bar (Angled)

Pipe Material: **Clay** ☐ Pipe Lined

Invert Depth: **15.48** (ft.) Flow Characteristics: **Fast**

Deposits: ☒ None ☐ Mud ☐ Sludge ☐ Debris ☐ Grease

Infiltration: **None** Pipe Seal Cond: **Unknown**

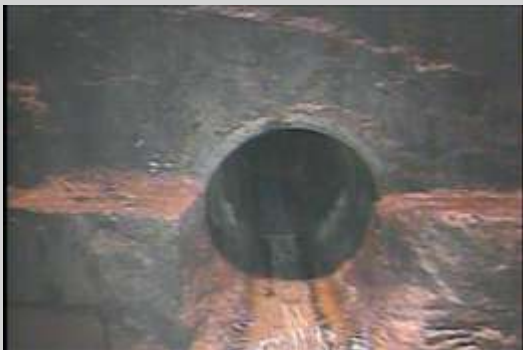
9 O'Clock Inflow

8 in. Circular Gravity Sewer

Pipe In @ 9 O'Clock

Pipe Height: **8.4** (in.) Rod and Bar (Angled)

Pipe Material: **Clay** ☐ Pipe Lined

Infiltration: **None** Pipe Seal Cond: **Sound**
